RENAULT FUEGO 2.0 L GTX

BRAKE PRESSURE LIMITER VALVE

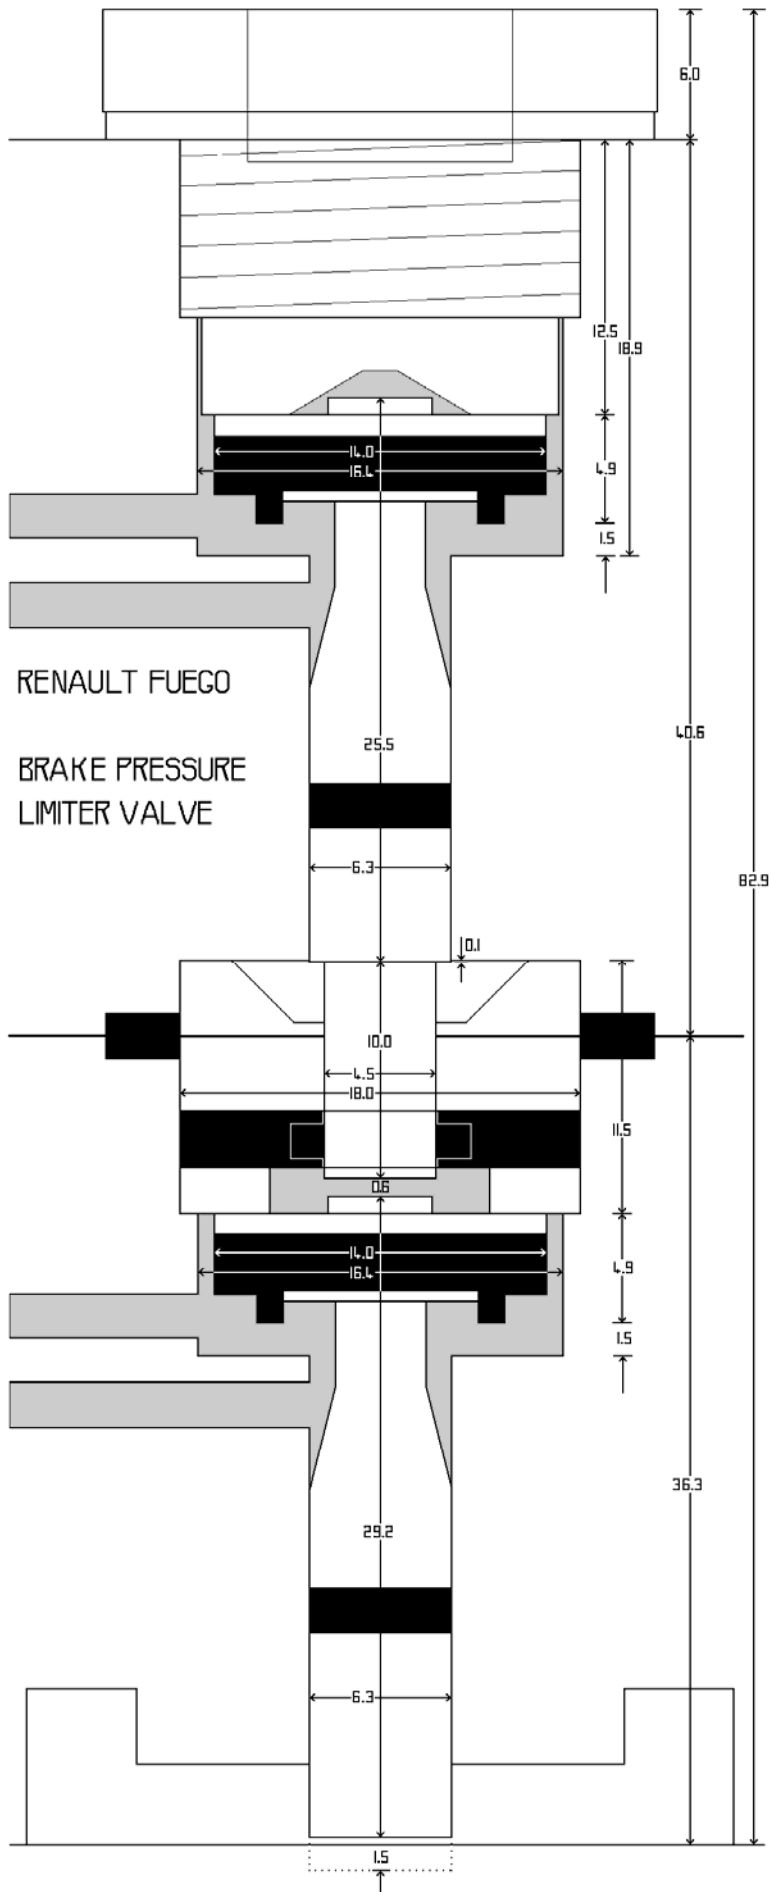
If by this stage, all of what is written sounds double-dutch, consult the diagram.

When the rear of the car is raised, the pistons (and the piston taper) are free to move at least 1.5 mm, under pressure of the fluid in the braking system, away from the screwed plug end, causing the rear brake lines to be blocked by the valves on the pistons. This puts all the braking effort on the front brakes.

I don't know what the significance of the 0.6 mm gap between the spacer piston and the two main pistons at rest is but it exists. Perhaps there must be some accommodation when the valve rubbers press down hard on the seats and distort.
